Situation Photo Log

Wednesday, June 20, 2012

Kalamazoo River / Enbridge Spill

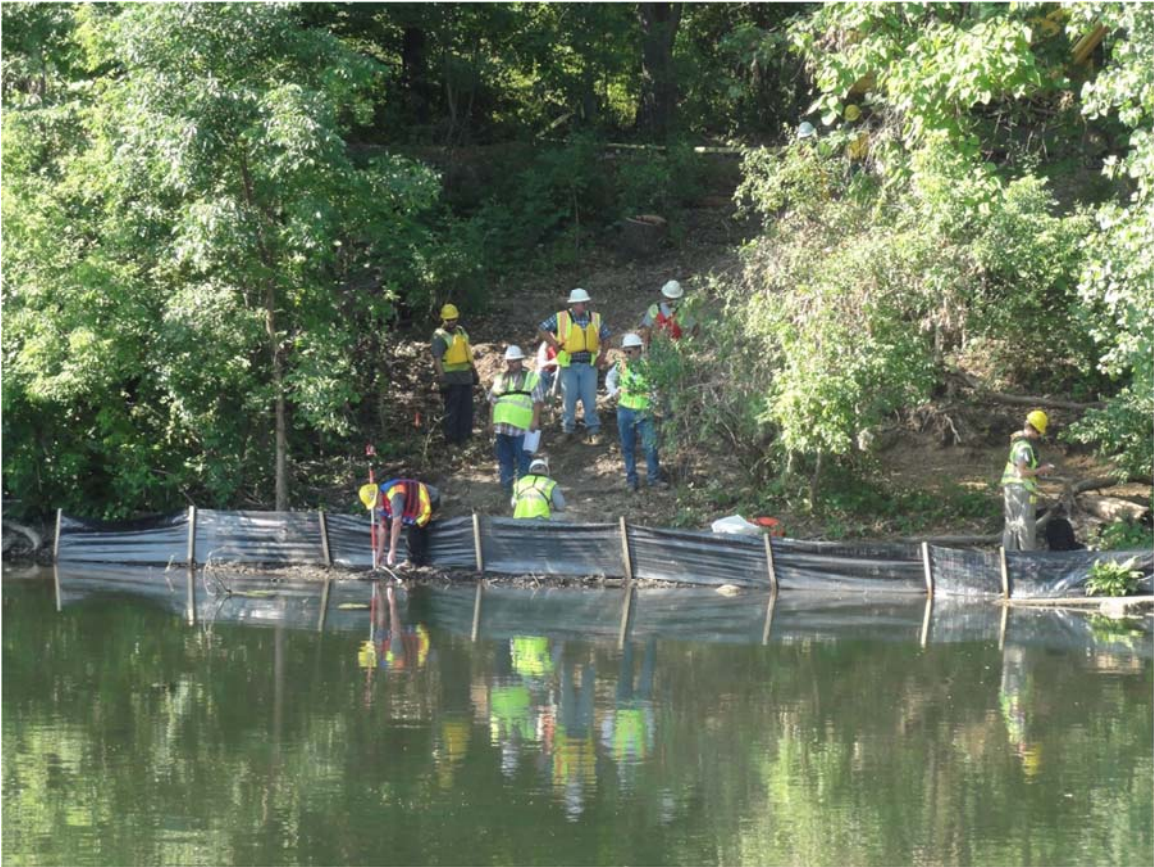
1. Ceresco Dam upstream portage observed being constructed.

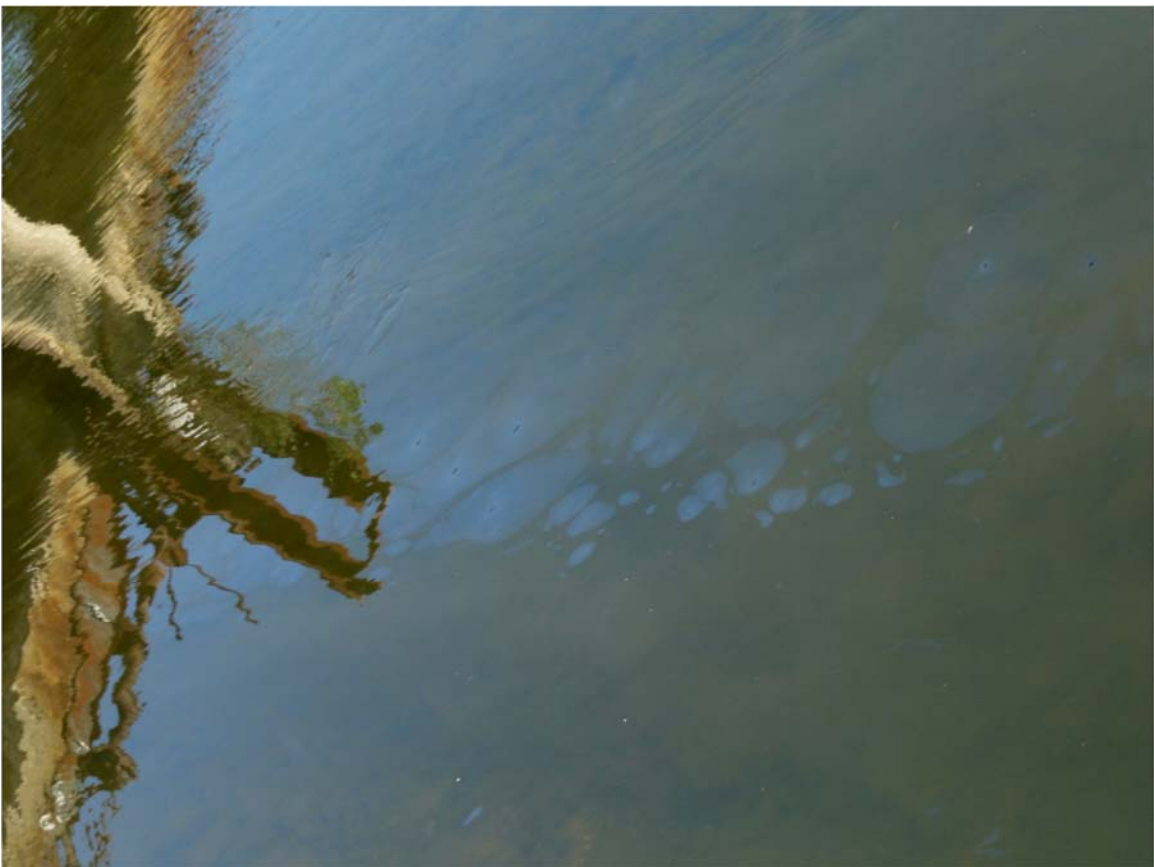
2. Ceresco Dam sheen and tar globs observed.

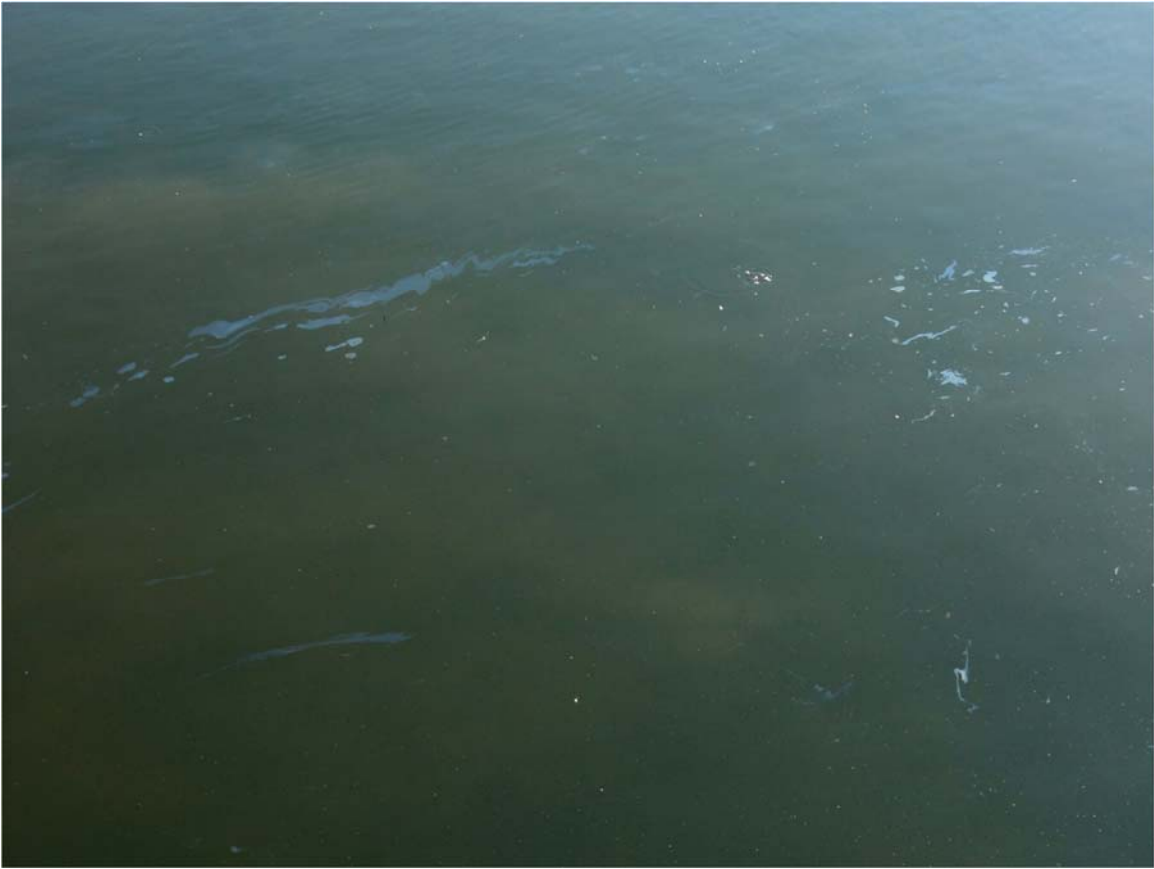
3. Ceresco Dam sheen observed.

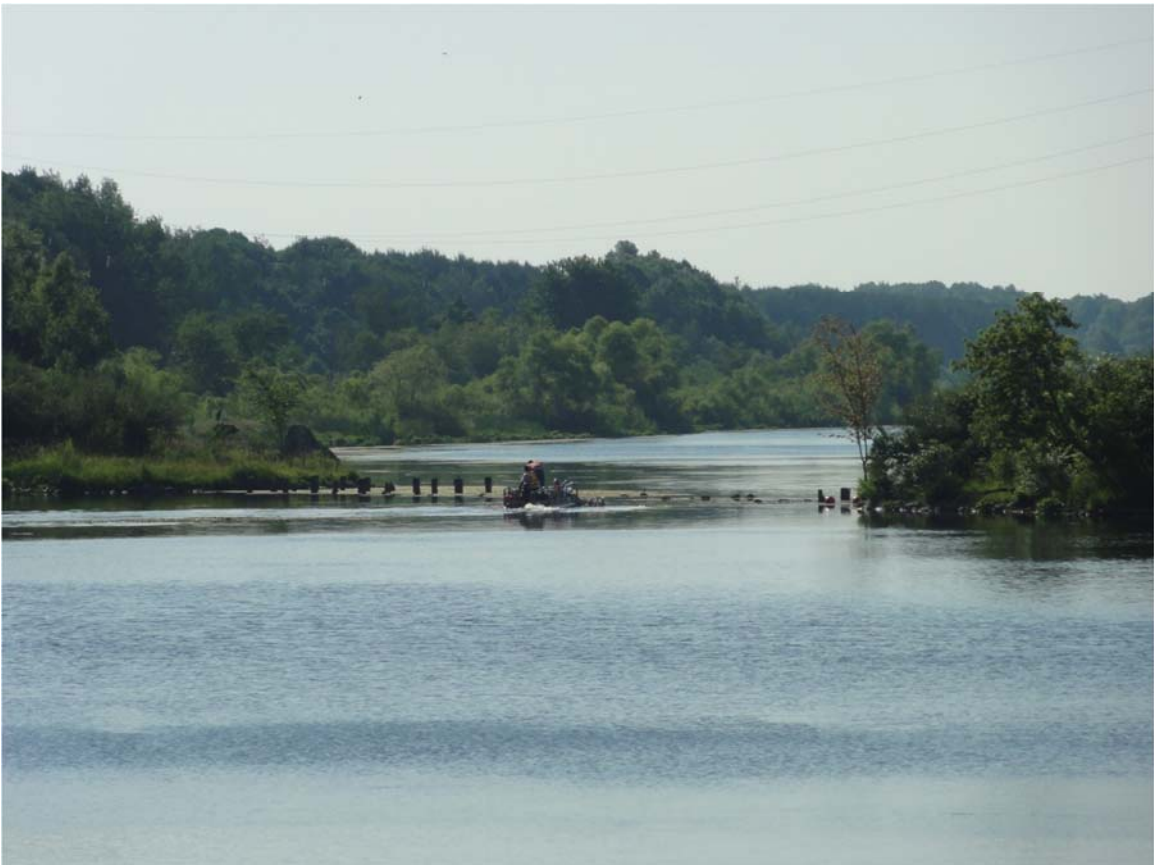
4. MP5.63 Observed crew removing vegetation from around trestles.

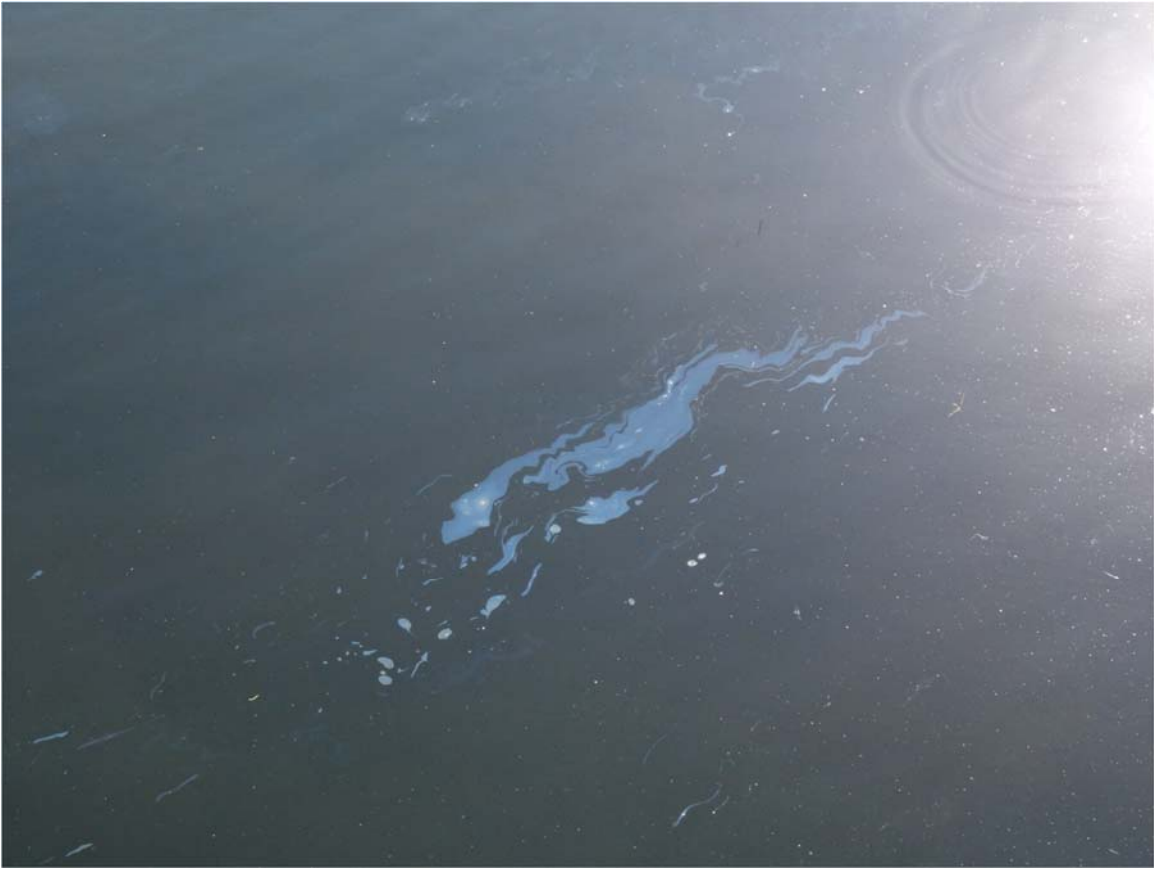
5. Ceresco Dam sheen observed.

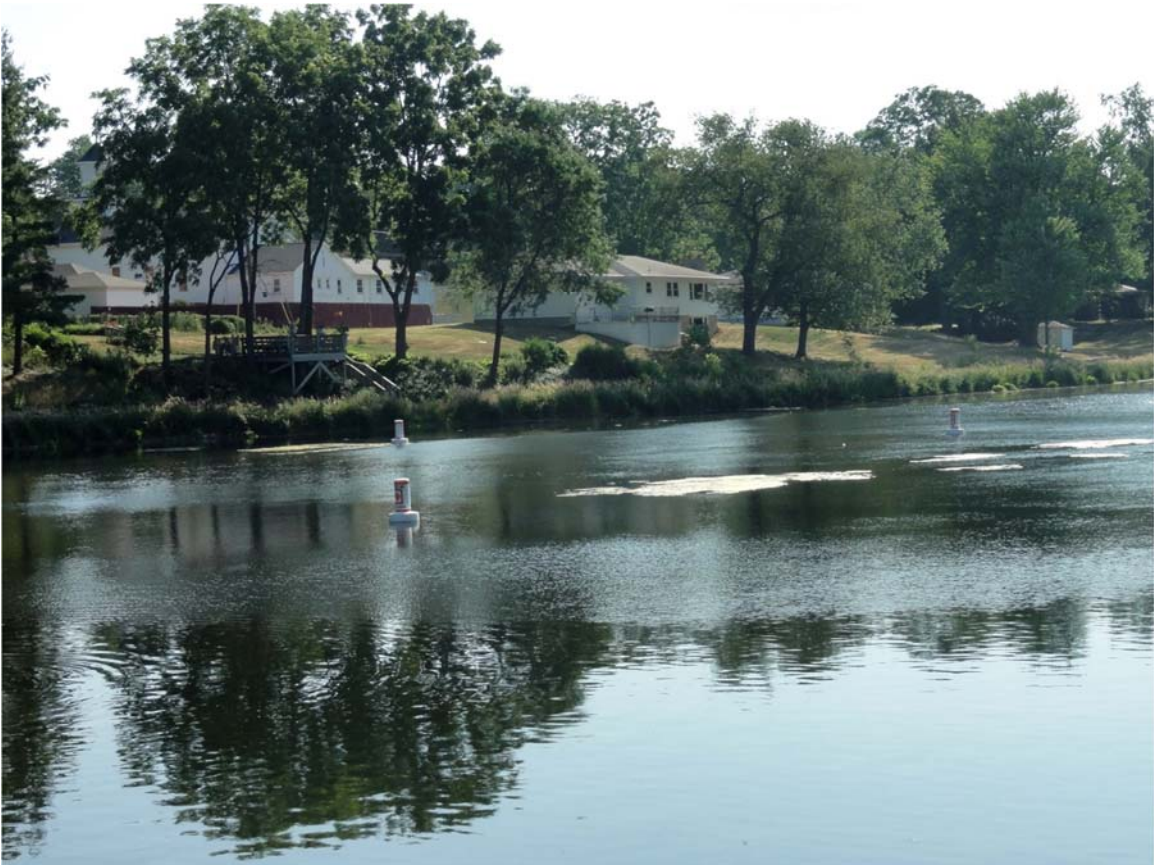
6. Ceresco Dam buoys reconfigured.

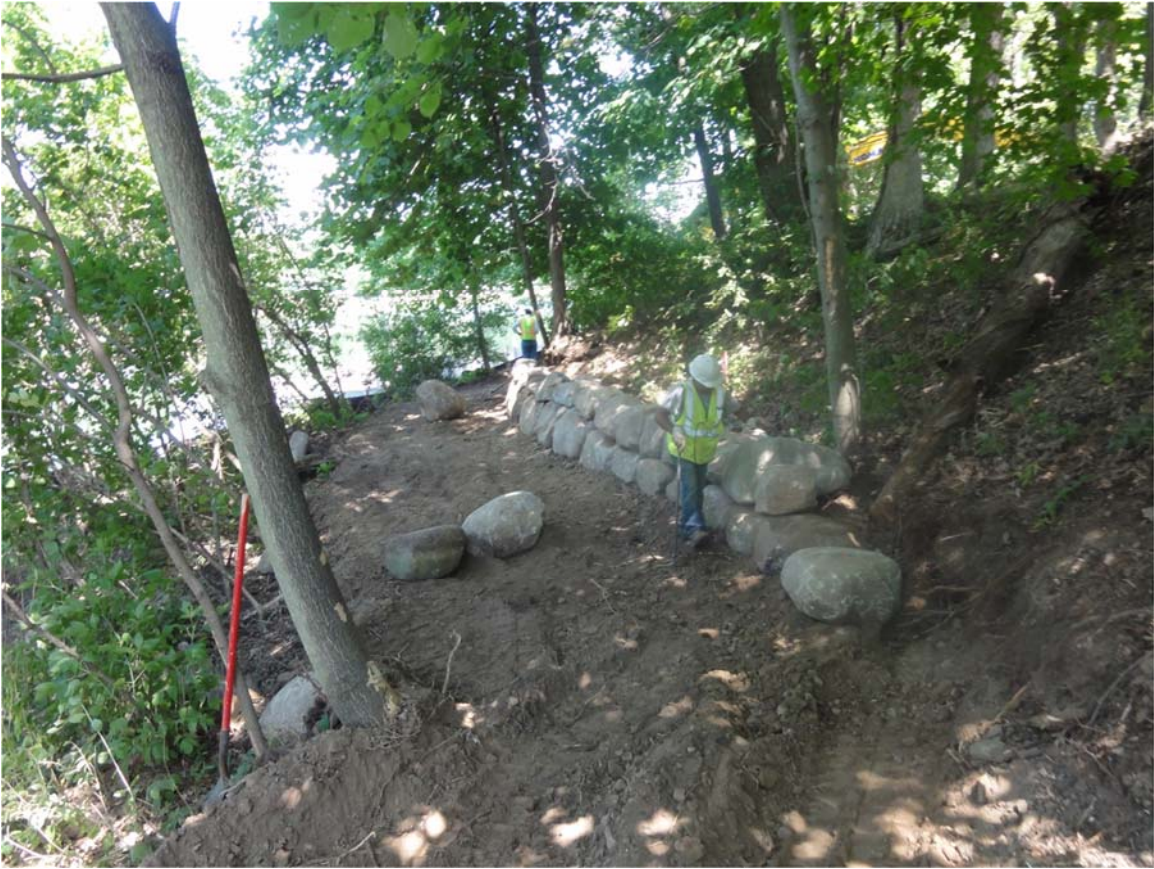
7. Ceresco Dam portage construction.

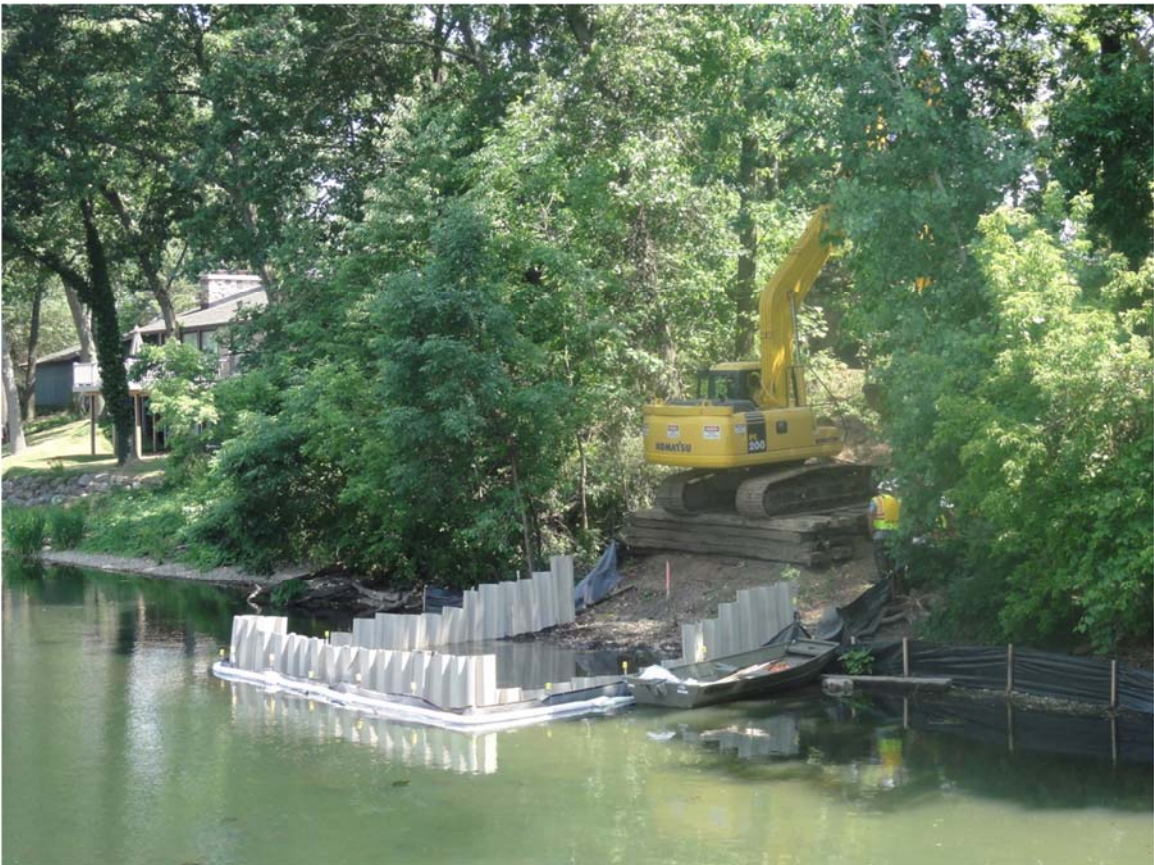
8. Ceresco Dam shoreline scrape.

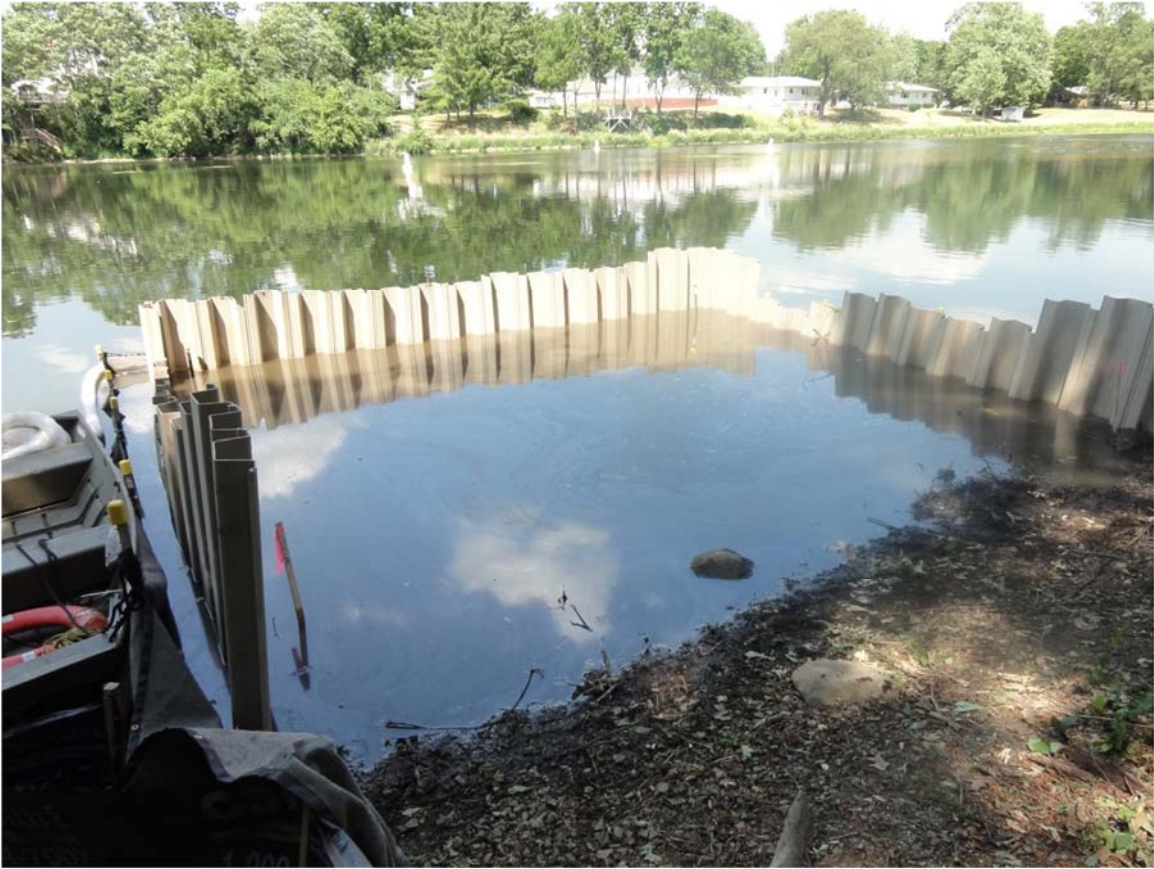
9. Ceresco Dam shoreline scrape.

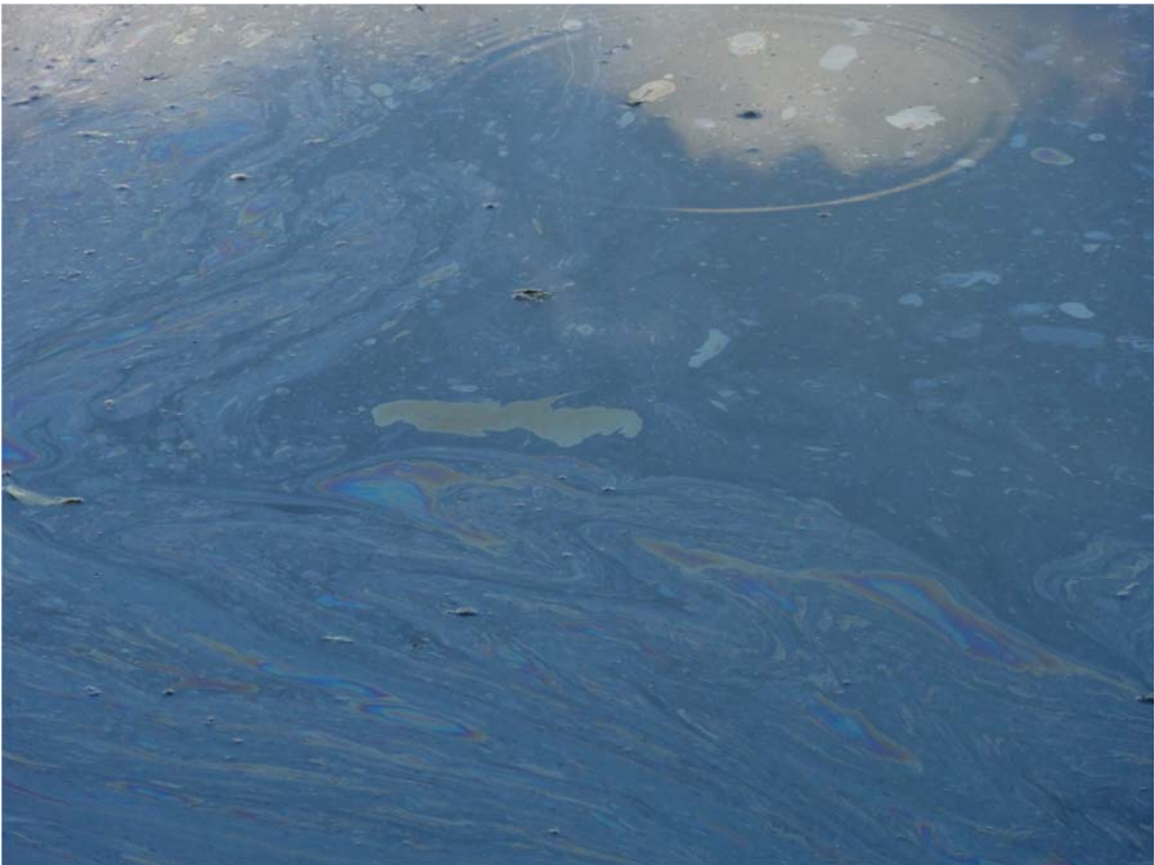
10. Ceresco Dam shoreline scrape work; sheen observed within sheet piling.

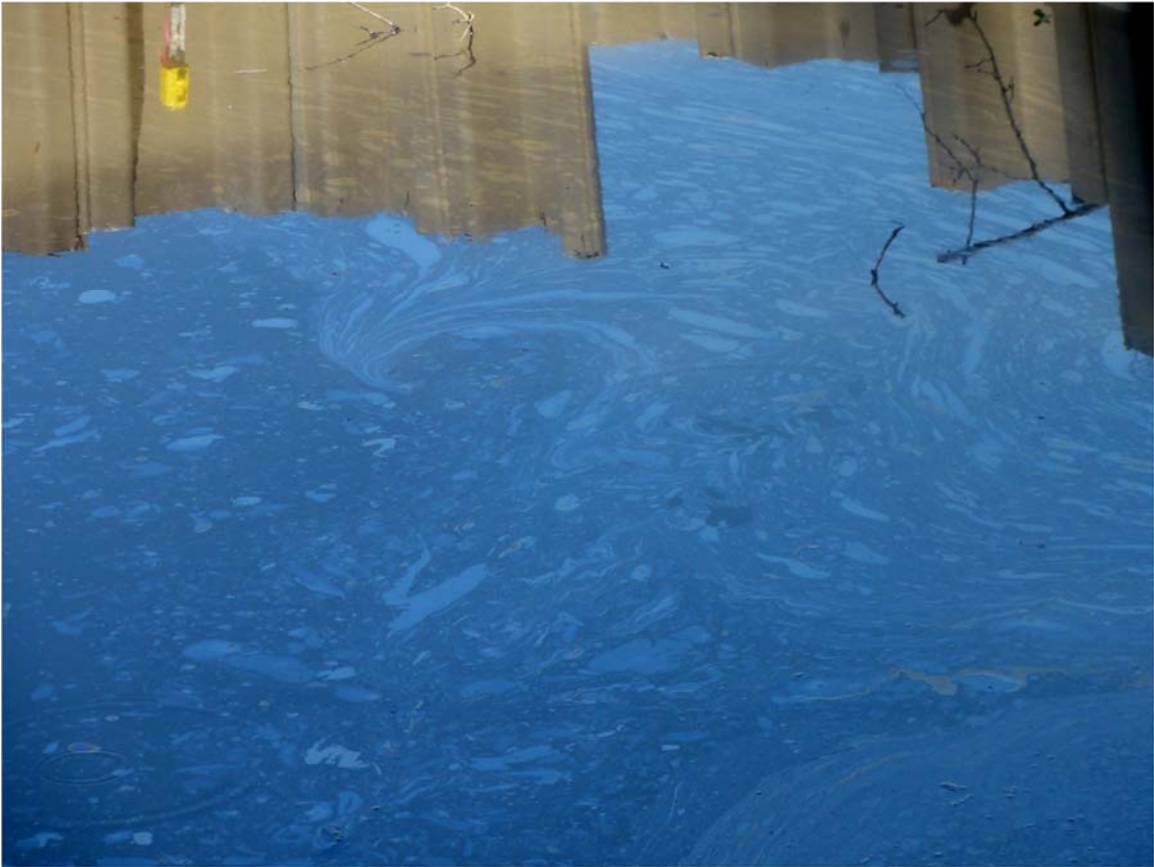
11. Ceresco Dam shoreline scrape work; sheen observed within sheet piling.

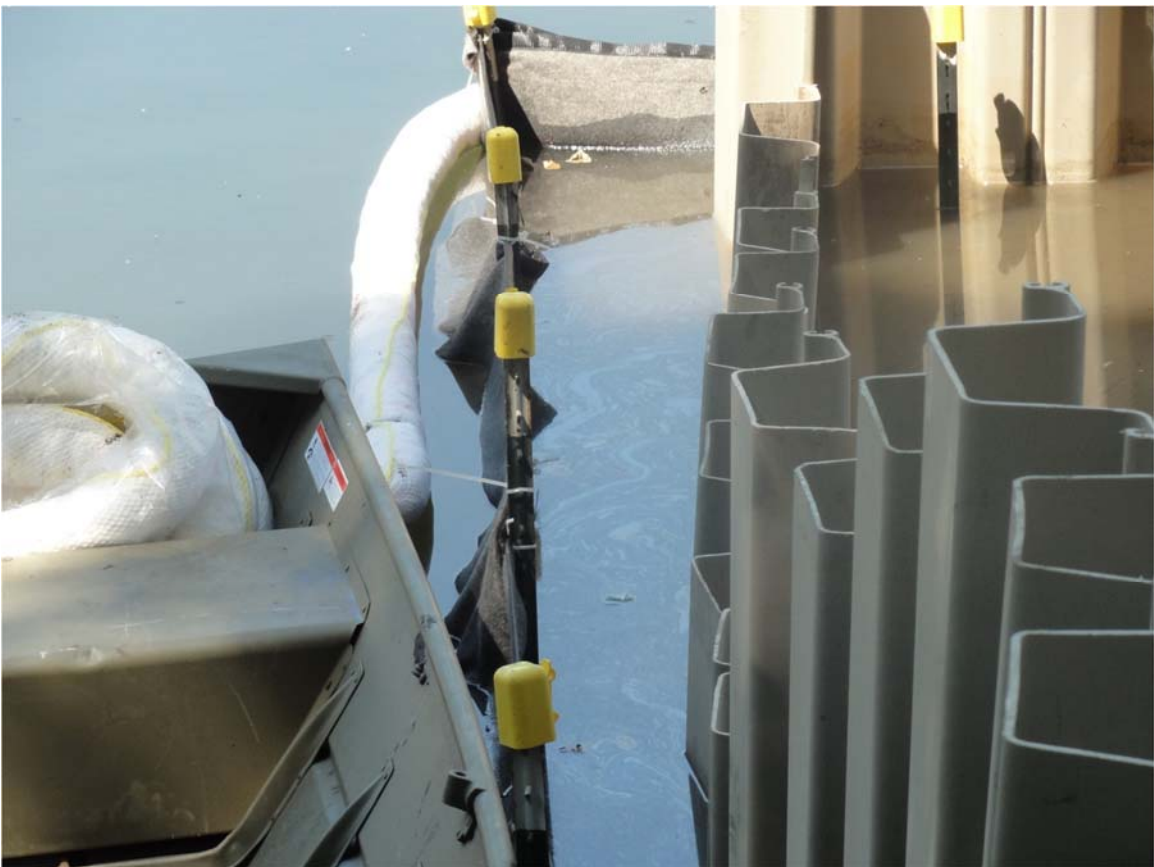
12. Ceresco Dam shoreline scrape work; sheen observed between sheet piling and curtain.

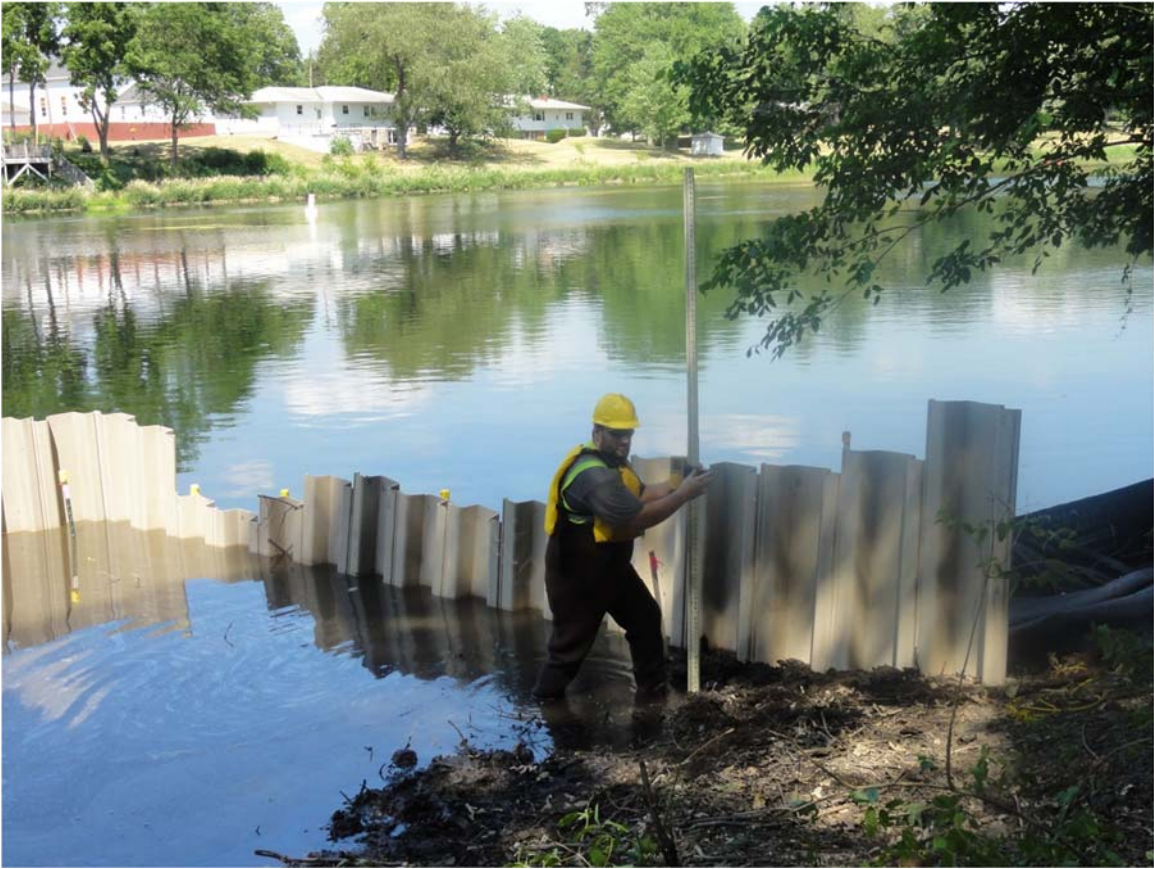
13. Ceresco Dam shoreline scrape work.

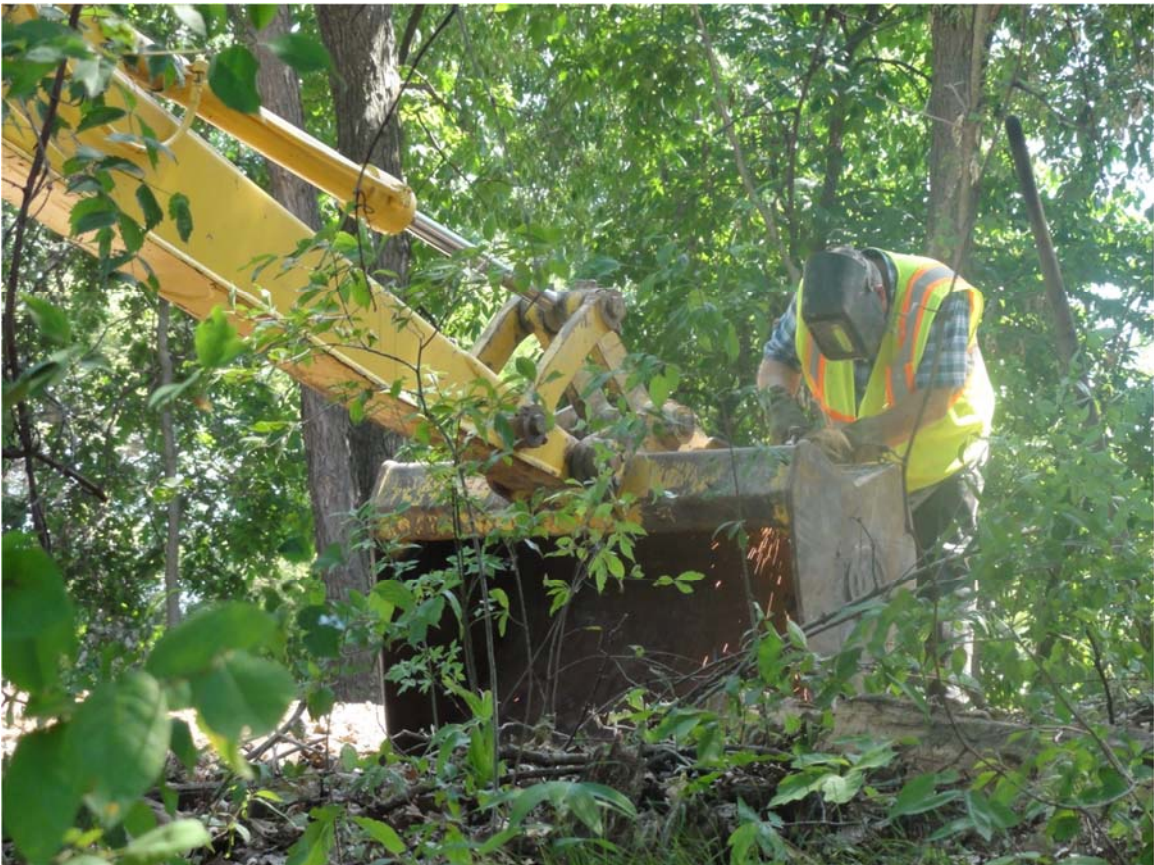
14. Ceresco Dam shoreline scrape work; worker cutting holes in bucket to drain water as it scrapes.

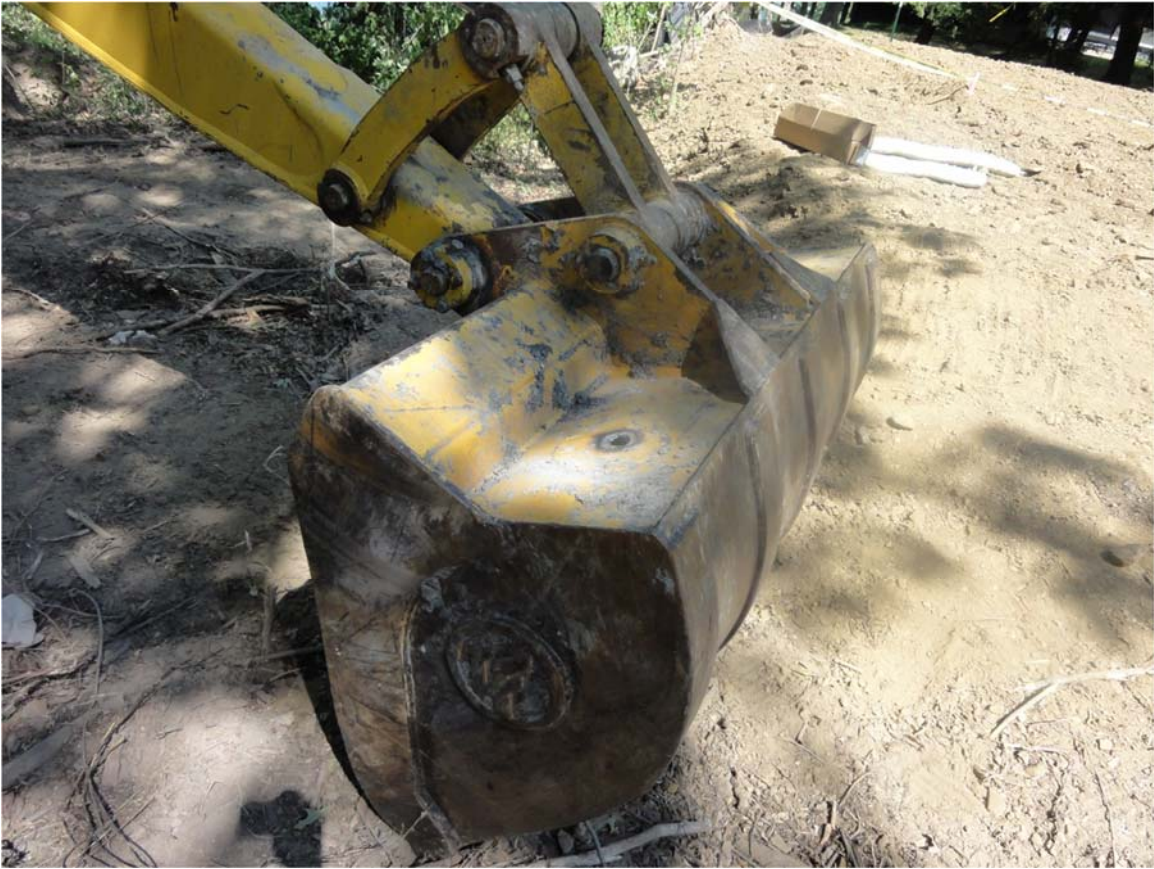
15. Ceresco Dam shoreline scrape work; worker cutting holes in bucket to drain water as it scrapes.

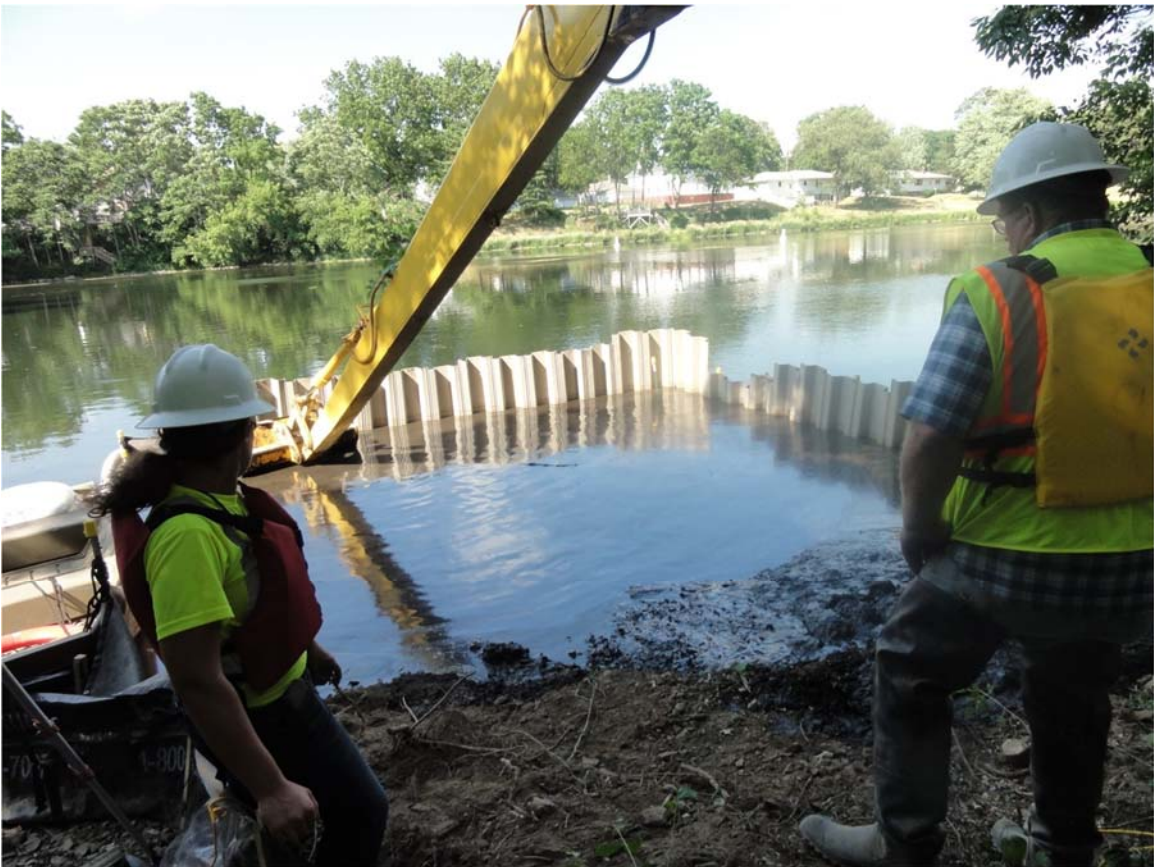
16. Ceresco Dam shoreline scrape work.

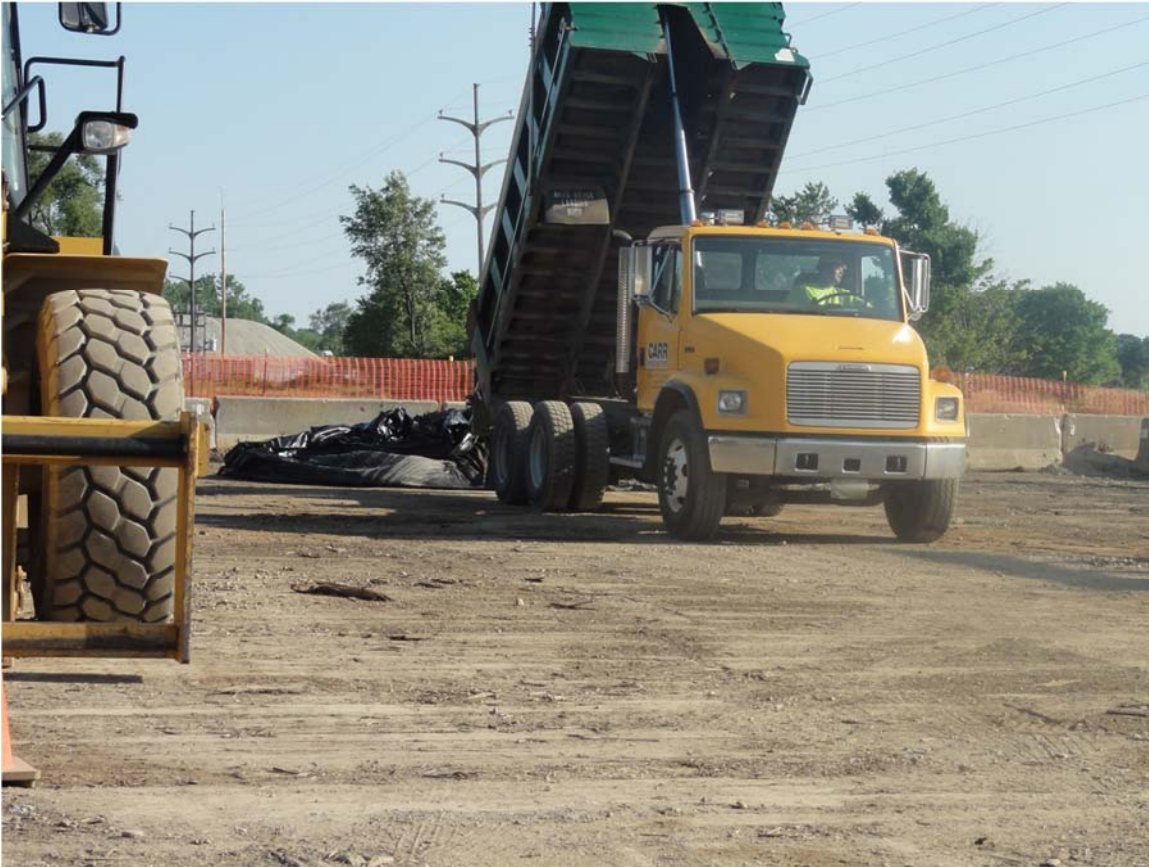
17. Ceresco Dam shoreline scrape work, soils being staged at Frac-City soil cells.

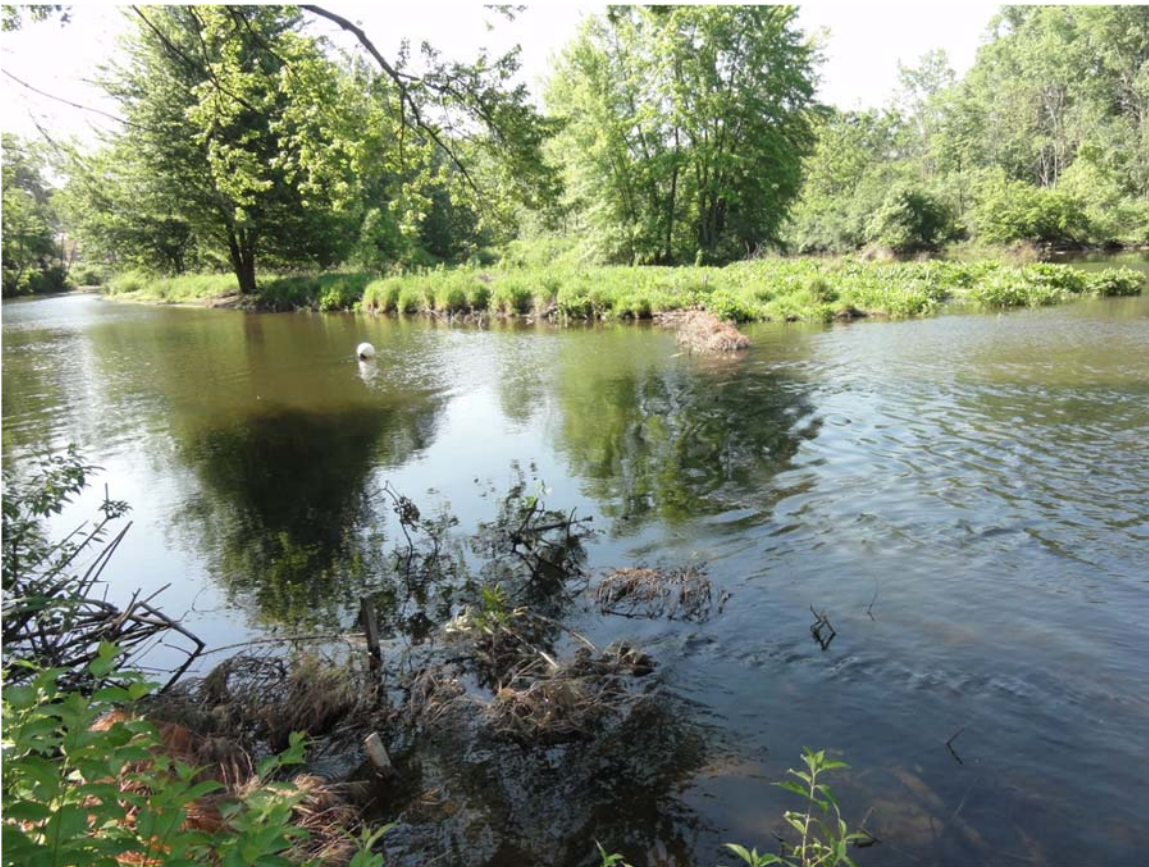
18. MP14.75 sediment trap.

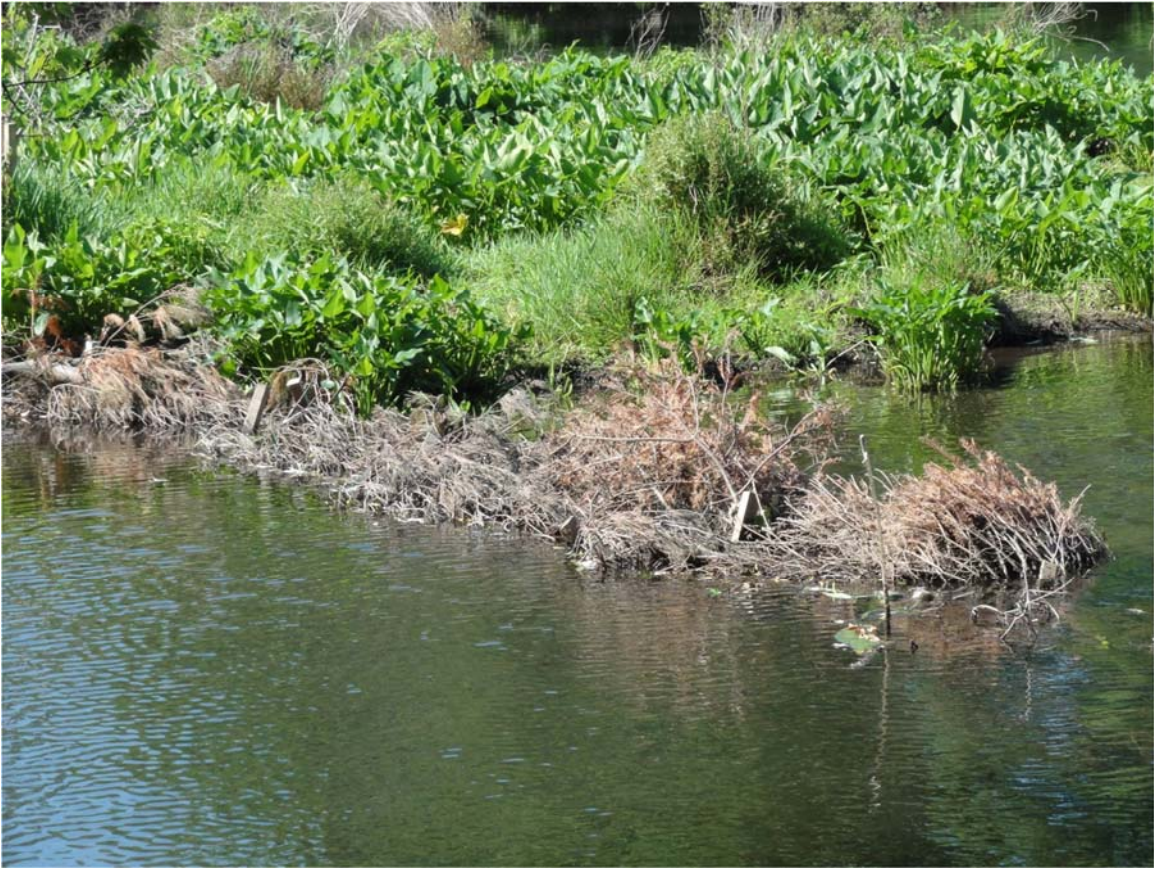
19. MP14.75 sediment trap.

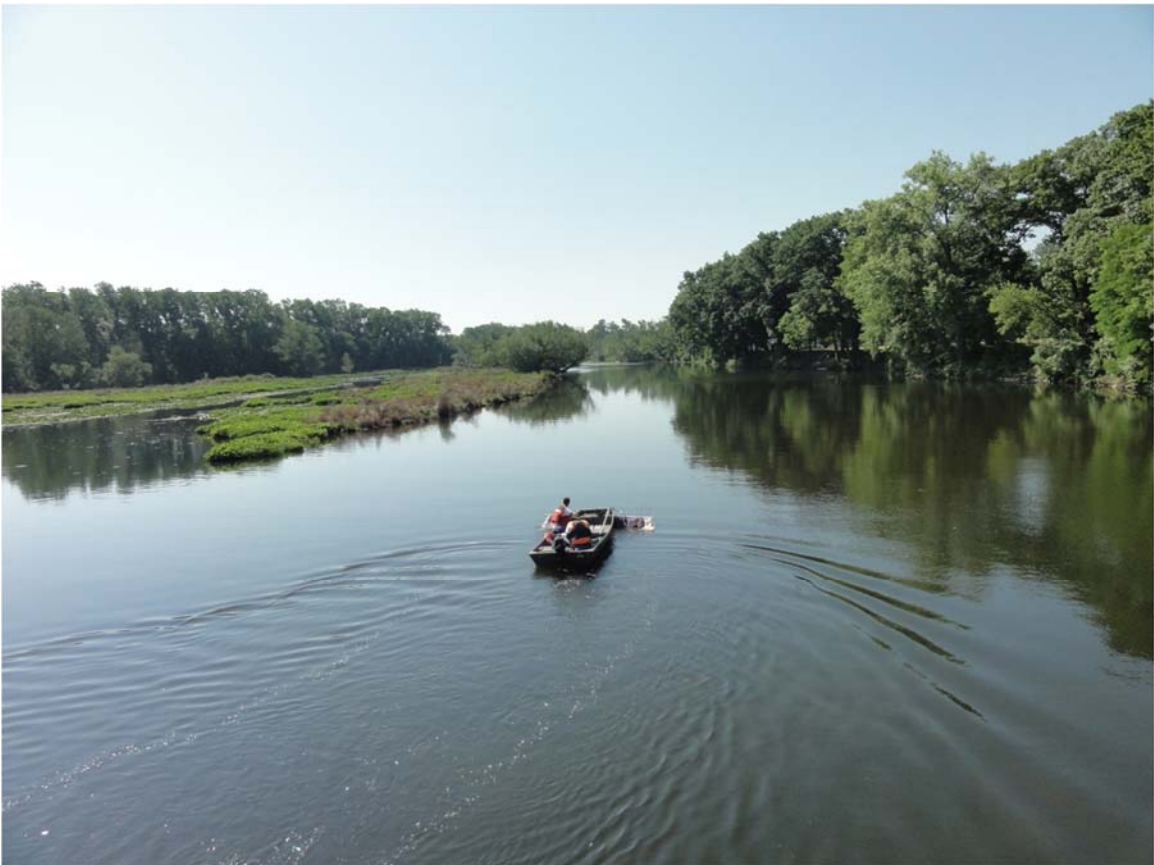
20. MP15.5 Mill Ponds sweep boat observed.

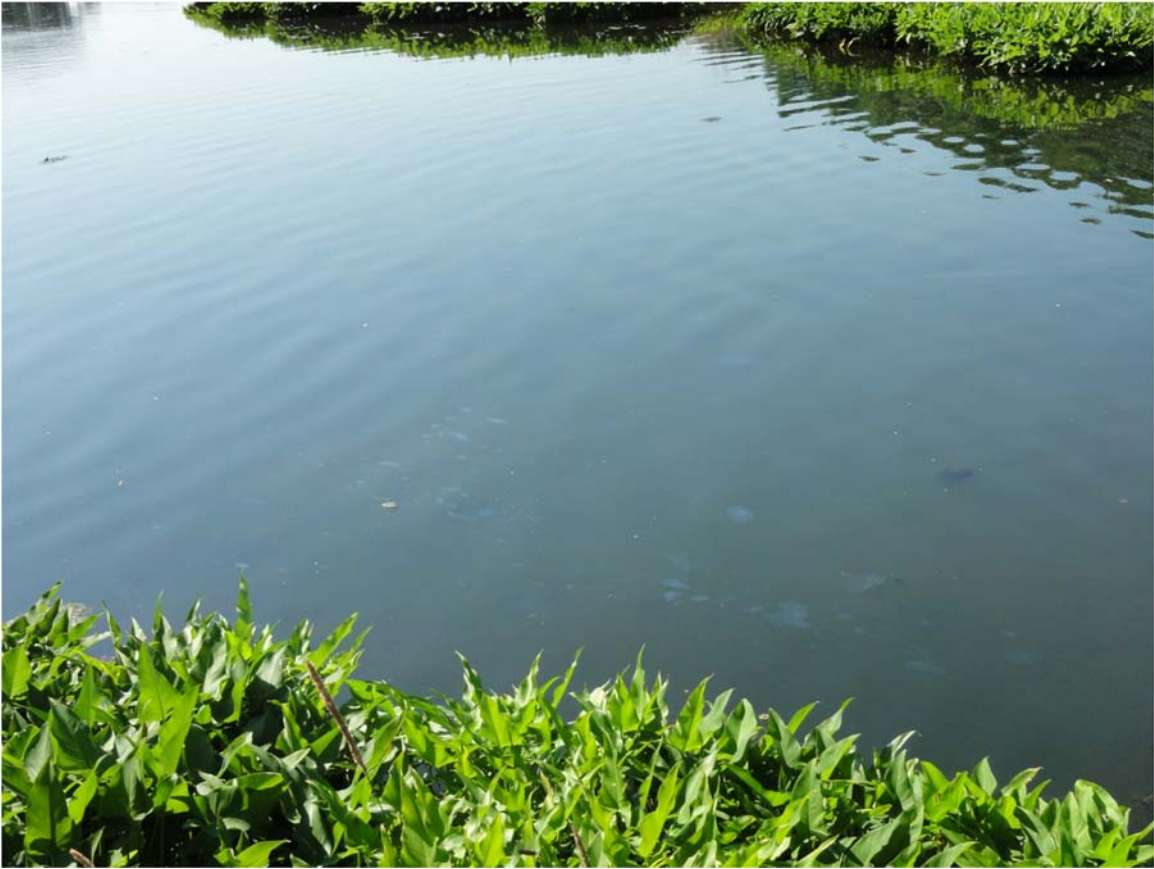
21. MP15.5 Mill Pond sheen observed.

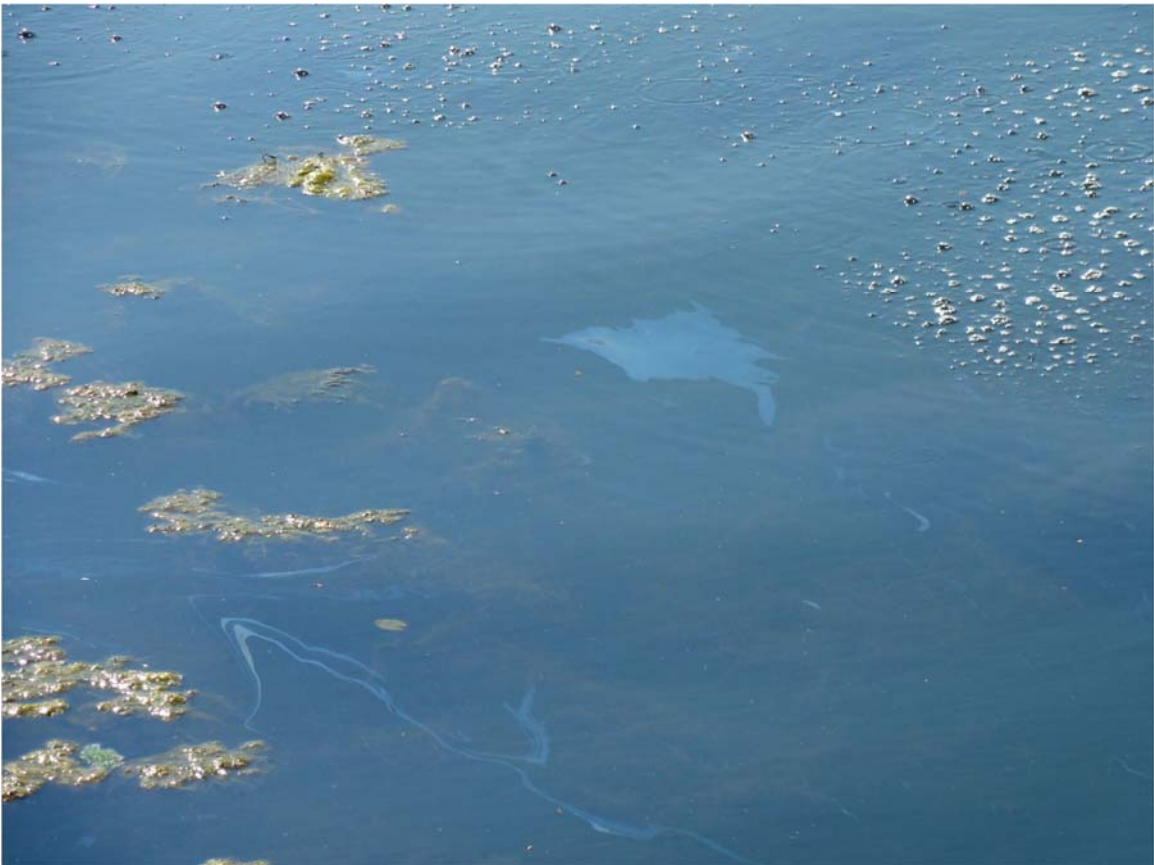
22. MP15.5 Mill Pond sheen observed.

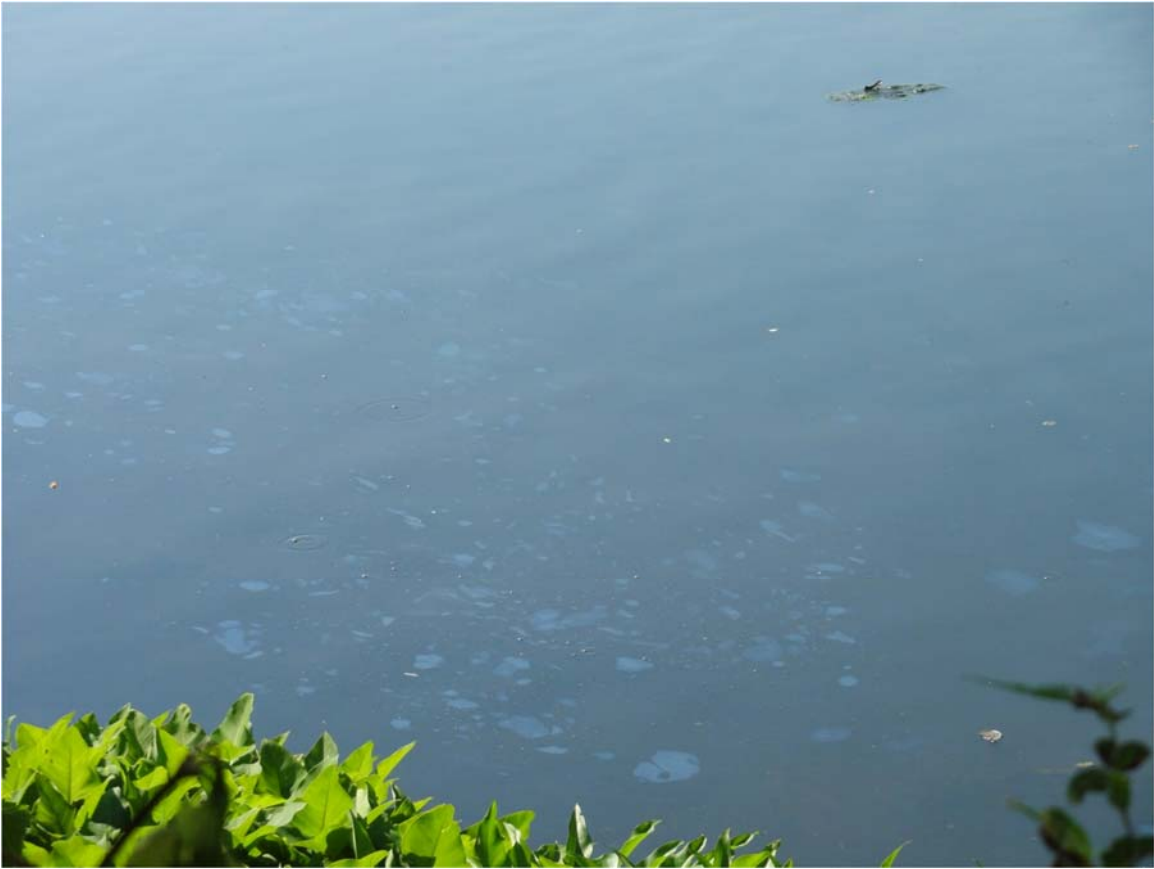
23. MP15.5 Mill Pond sheen observed.
